20-251E

Re: **World Trade Center**
New York, New York

One World Trade Center

World Trade Center
New York, New York

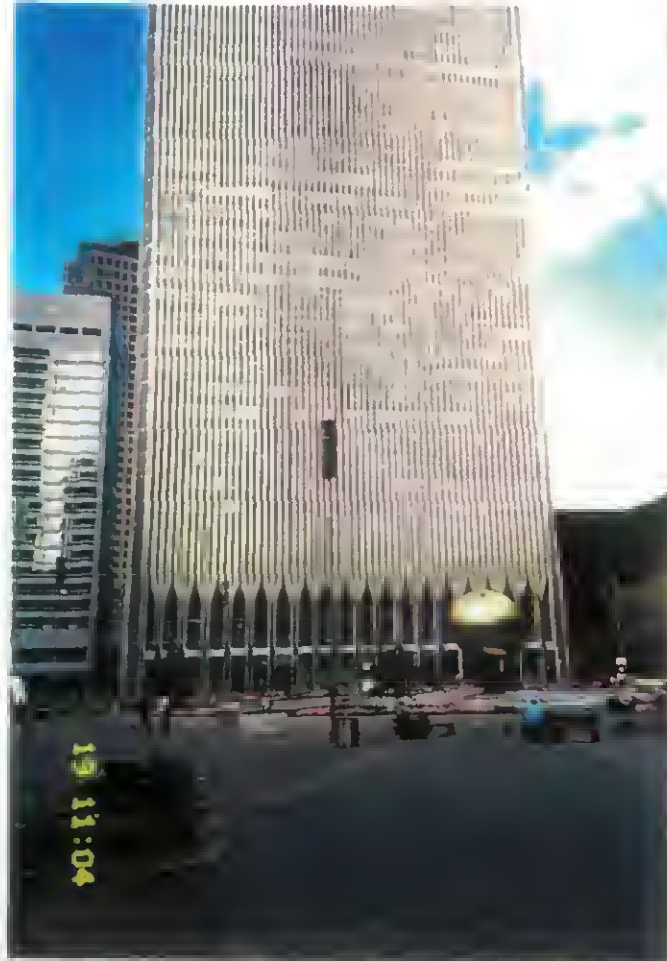
Photograph 1

Front plaza level
entrance (east)

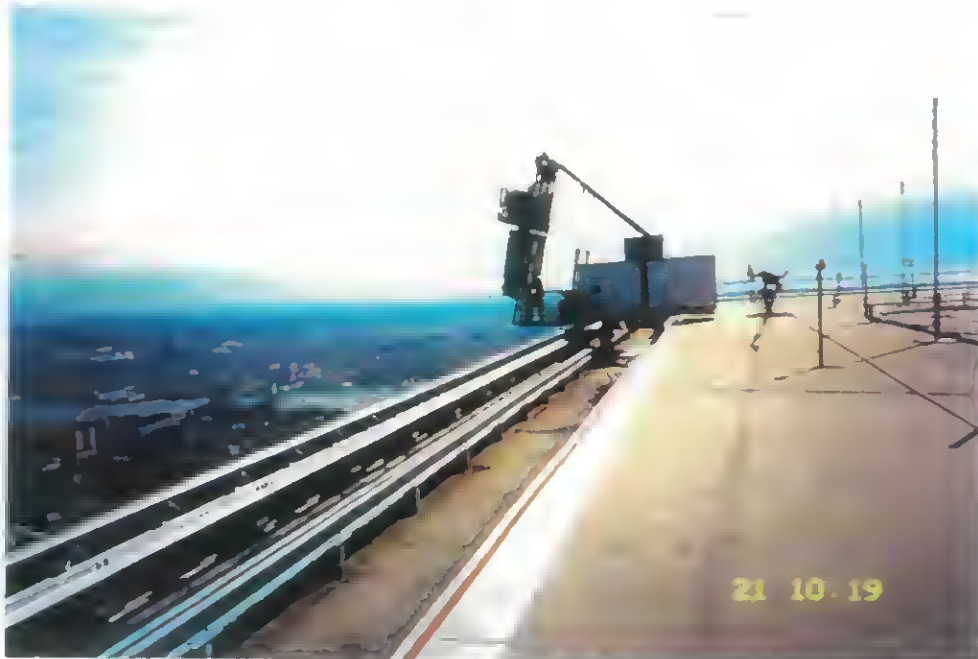
Photograph 5

Window washing rig

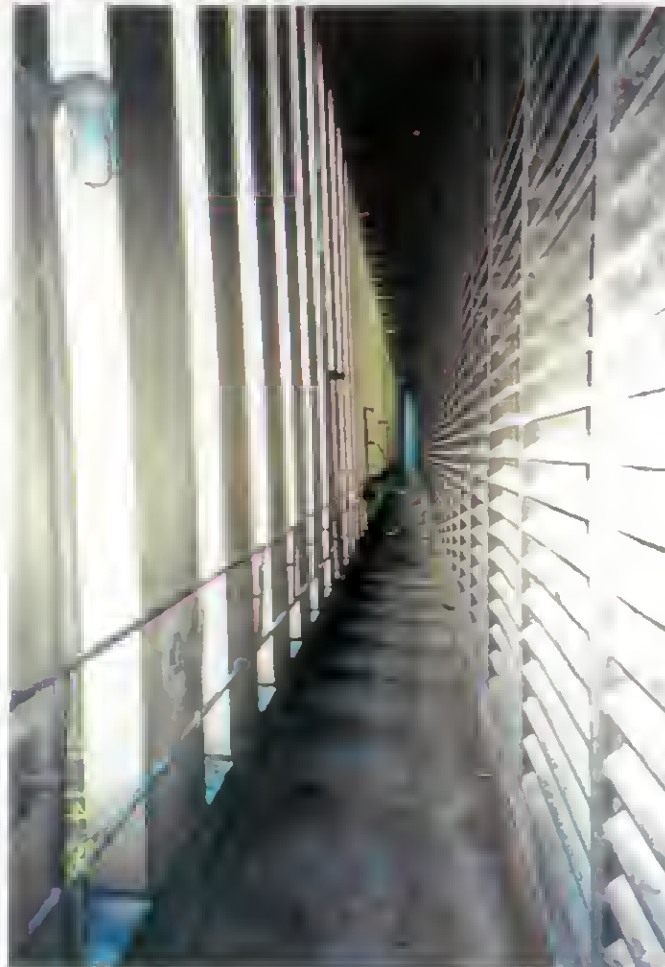
Photograph 6

Typical setback at
MER levels

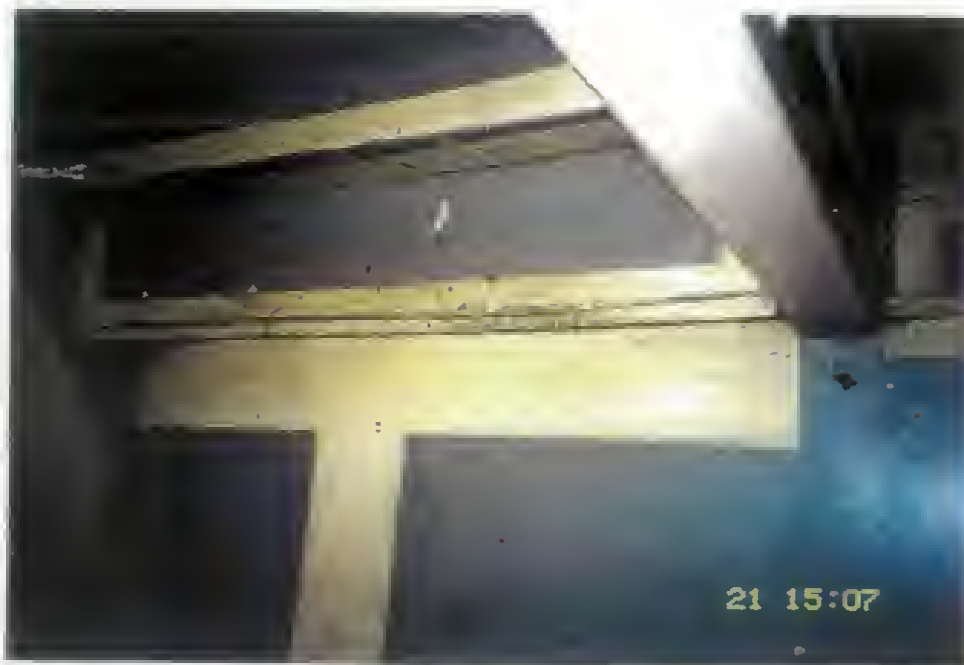
Photograph 21

Bent stair nosing on
wide stairs.

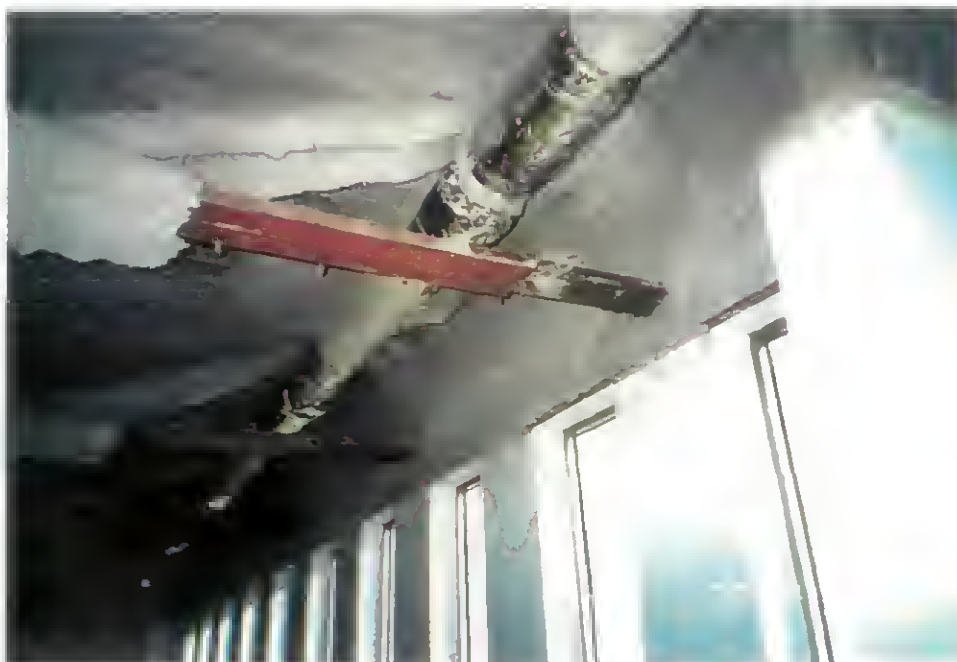
Photograph 22

Viscoelastic damper
at each floor joist.

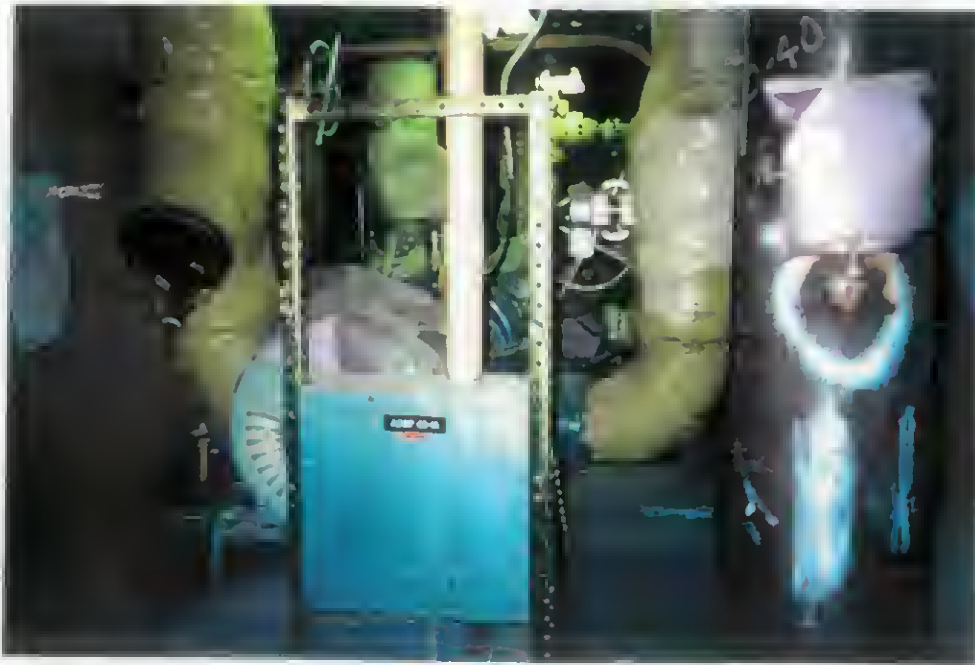
Photograph M1

Condenser water
system #2 pump

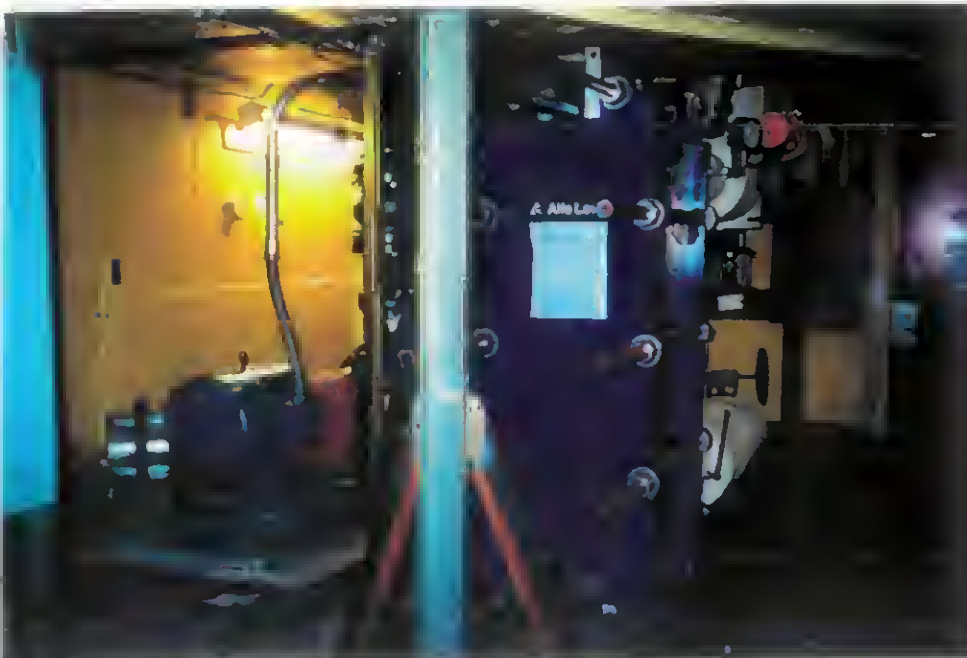
Photograph M3

**New condenser
water system #2
pump and plate
and frame heat
exchanger**

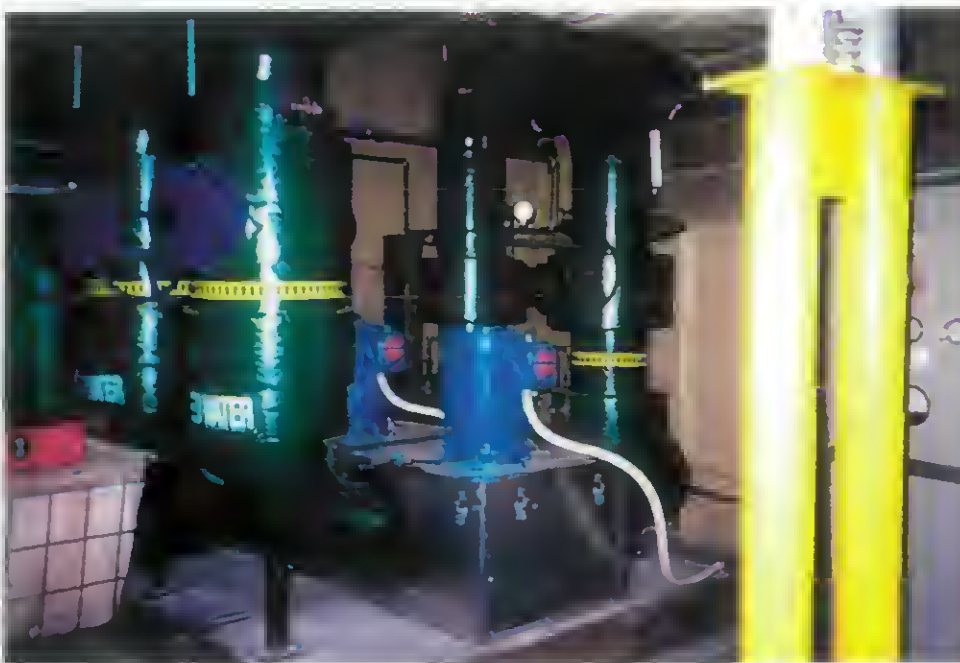
Photograph M4

**New freeze
protection
system chilled
water pumps**

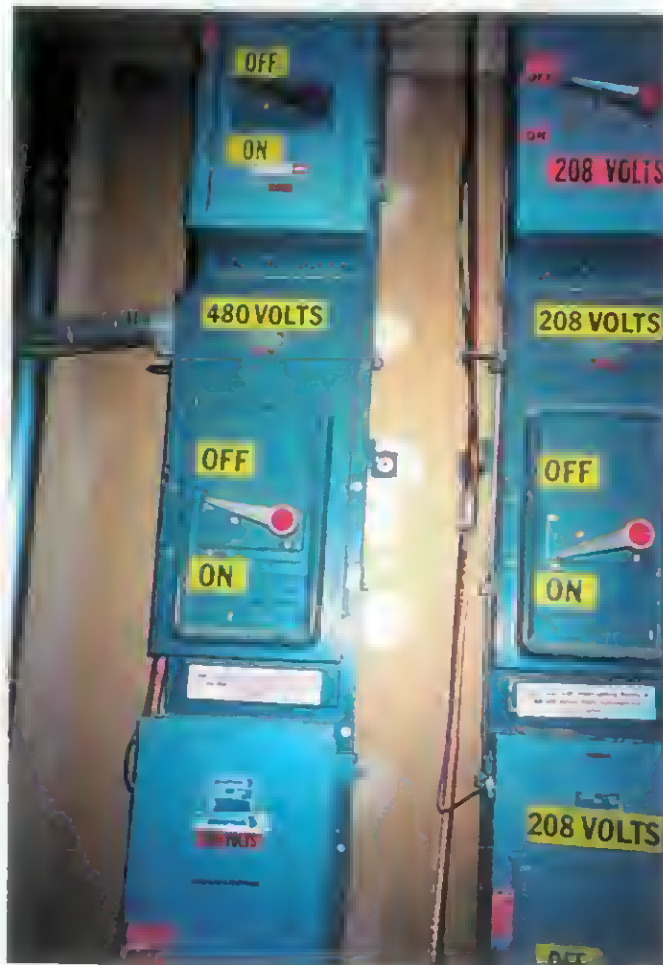
Photograph M5

480 volt and 208
volt electric bus
duct risers
located in a
typical electric
closet

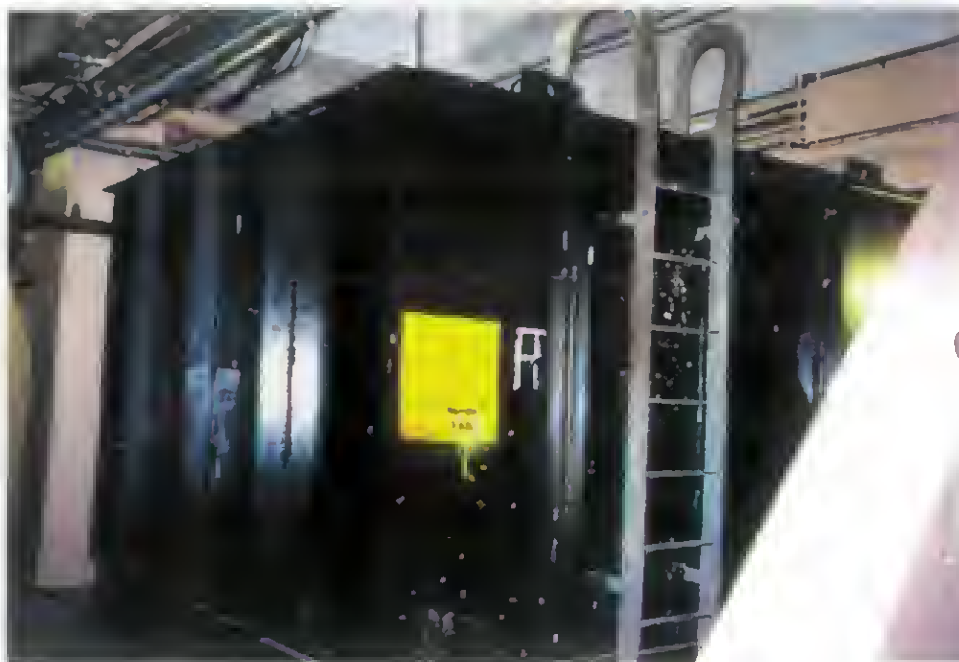
Photograph M6

5,000 gal.
standpipe fire
reserve tank

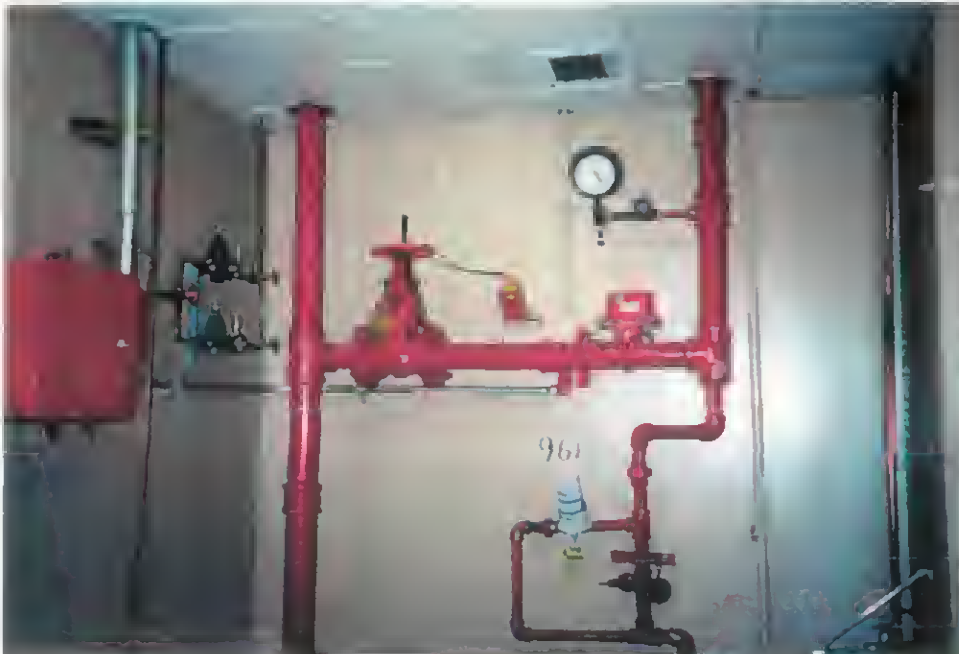
Photograph M7

Typical floor
sprinkler control
valve room with
sprinkler supply
line and flow and
tamper switches

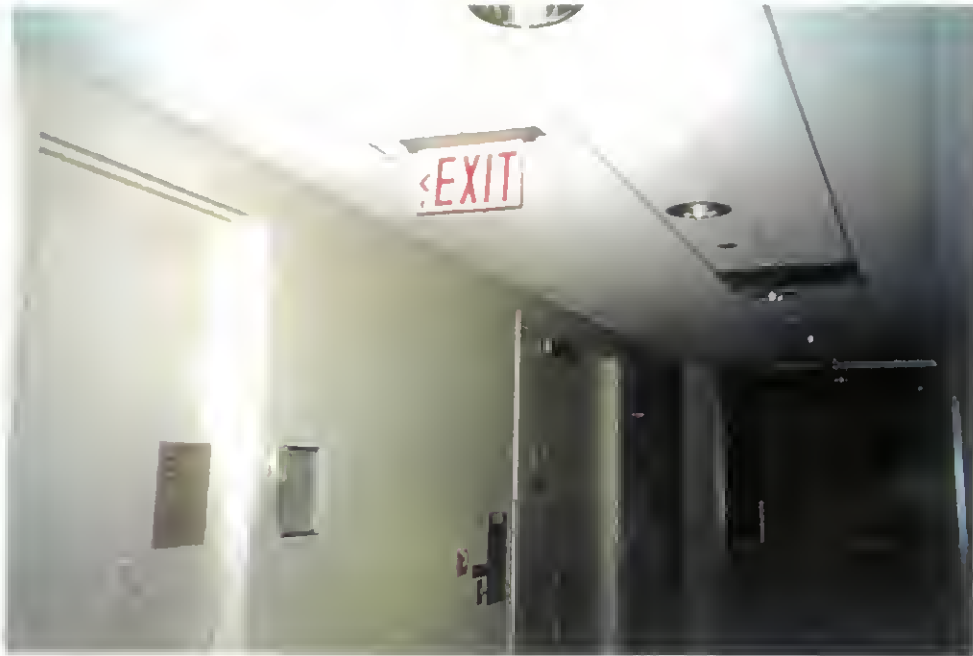
PhotographM9

Typical office
floor corridor
with an exit sign,
manual pull
station, fire
warden station,
and audio/visual
alarm

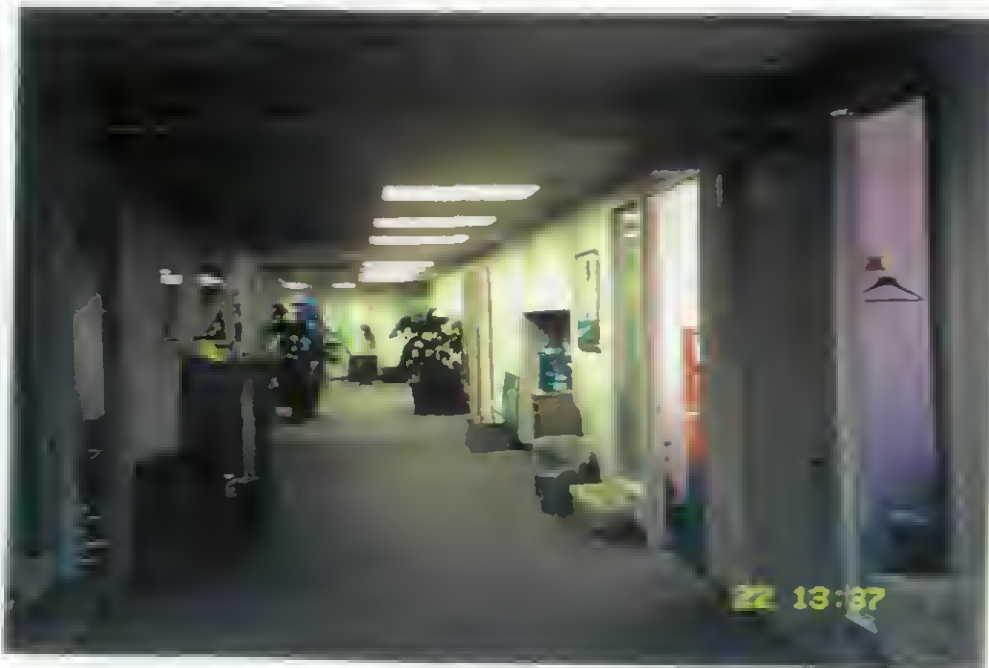
Photograph 20

Observation deck
eating area

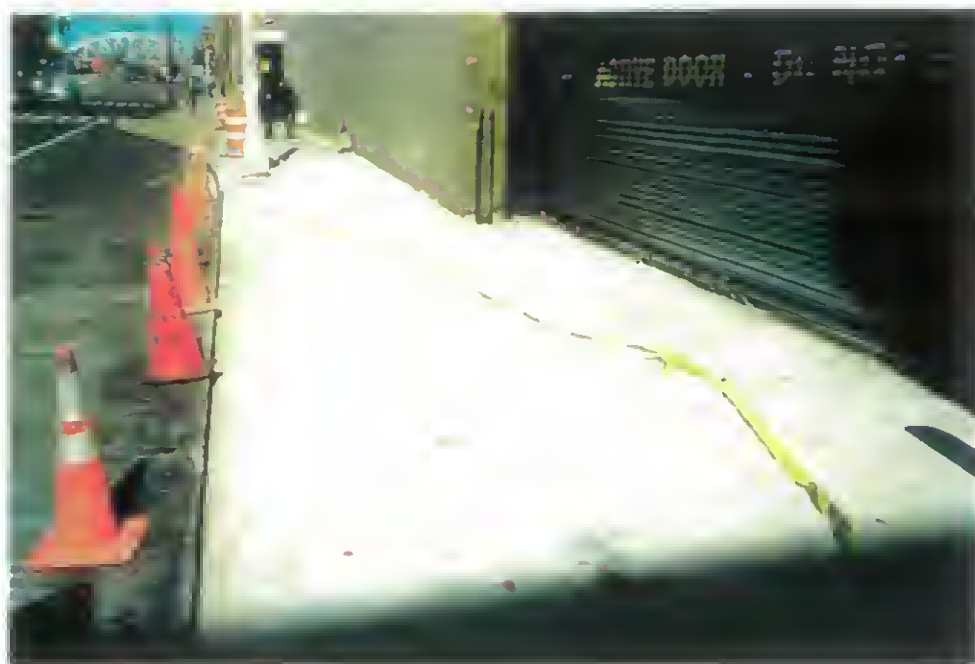
Photograph 3

**Sidewalk
conditions along
Vesey Street near
West Broadway**

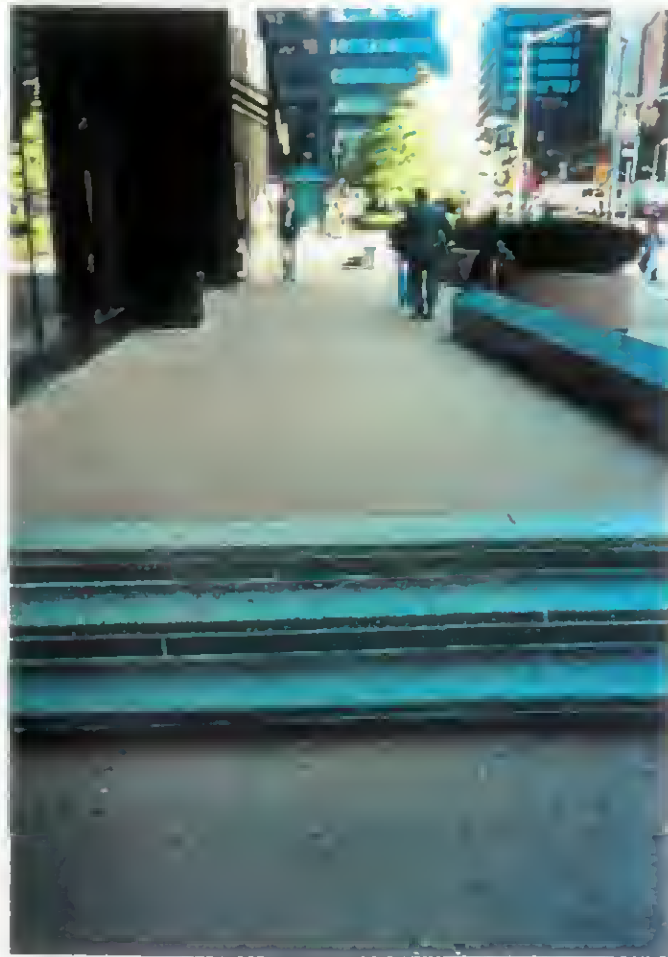
Photograph 8

**New granite
pavement south
at 2 WTC
entrance**

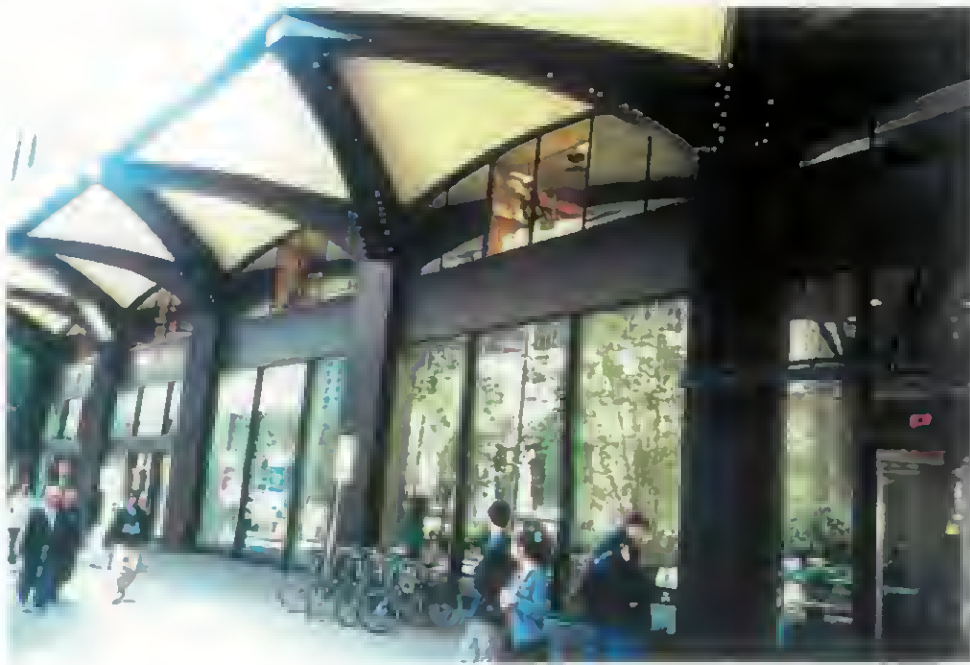
Photograph 22

Exterior finishes
and space under
overhang being
used for
restaurant
seating

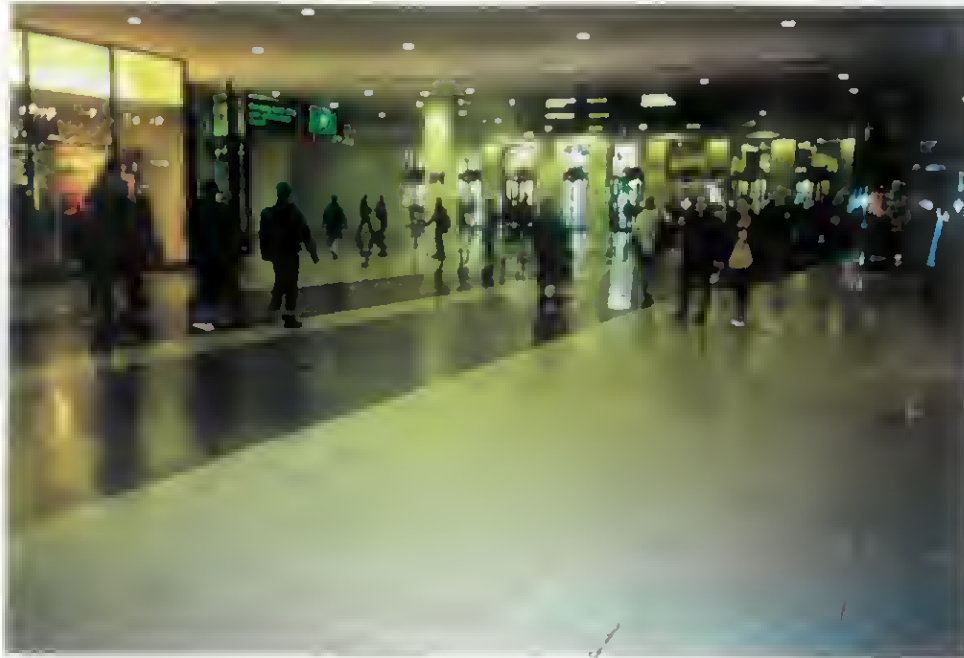
Photograph 30

Old travertine
flooring in an
area scheduled to
be replaced with
terrazzo

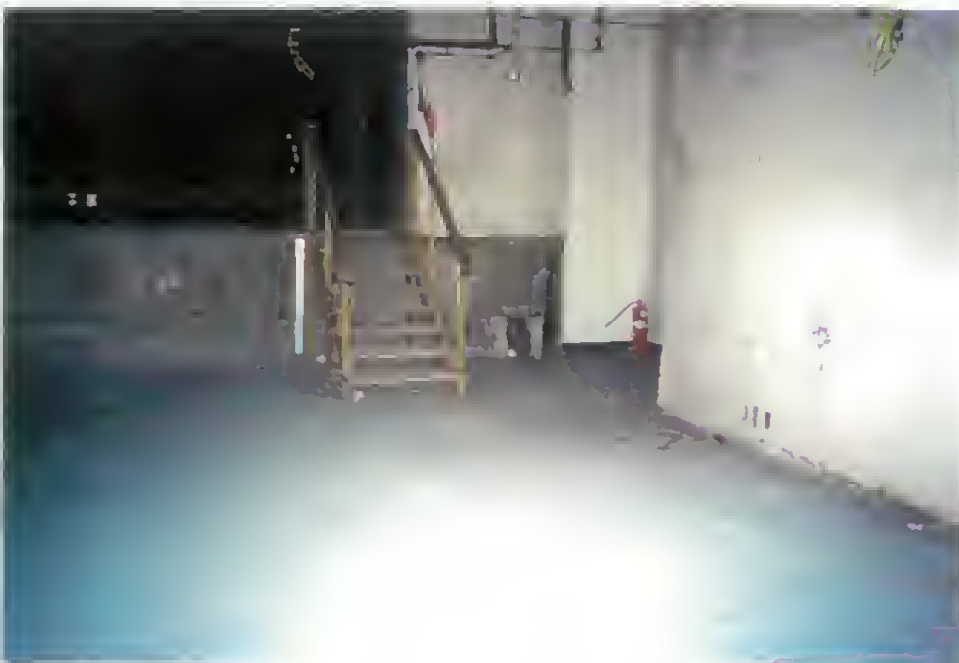
Photograph 47

**Vacant retail
space at Plaza
level below 4
WTC**

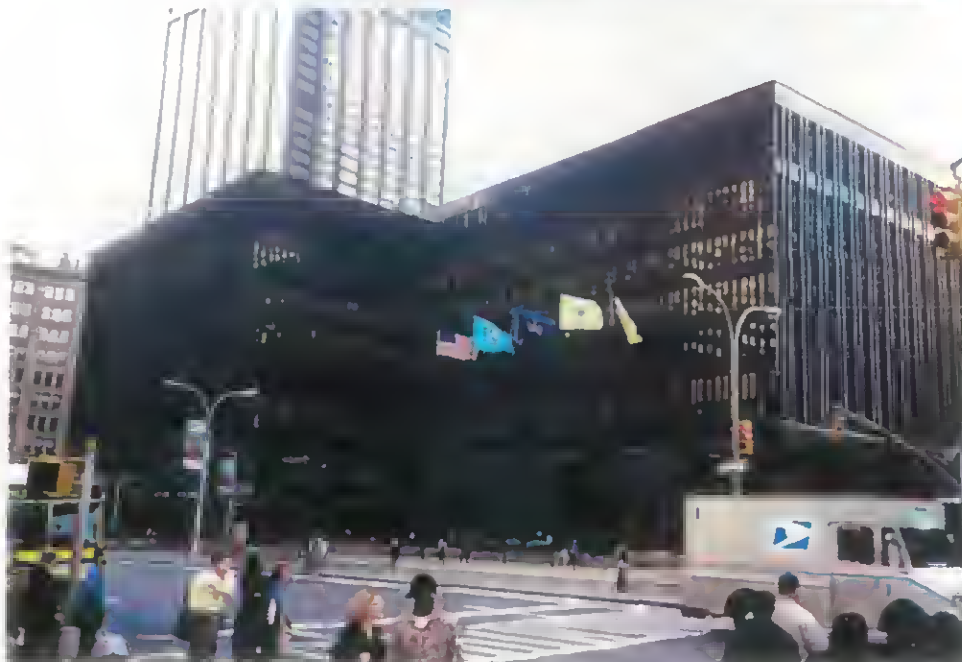
Photograph 7

Aluminum
cladding conceals
steel truss to
support
cantilever at 4th
floor overhang

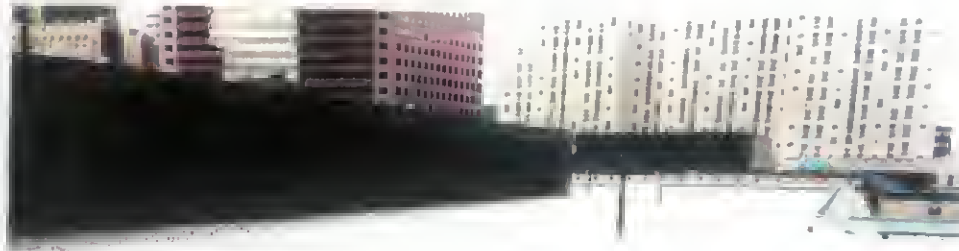
Photograph 14

**Roof layout
overview from
tower**

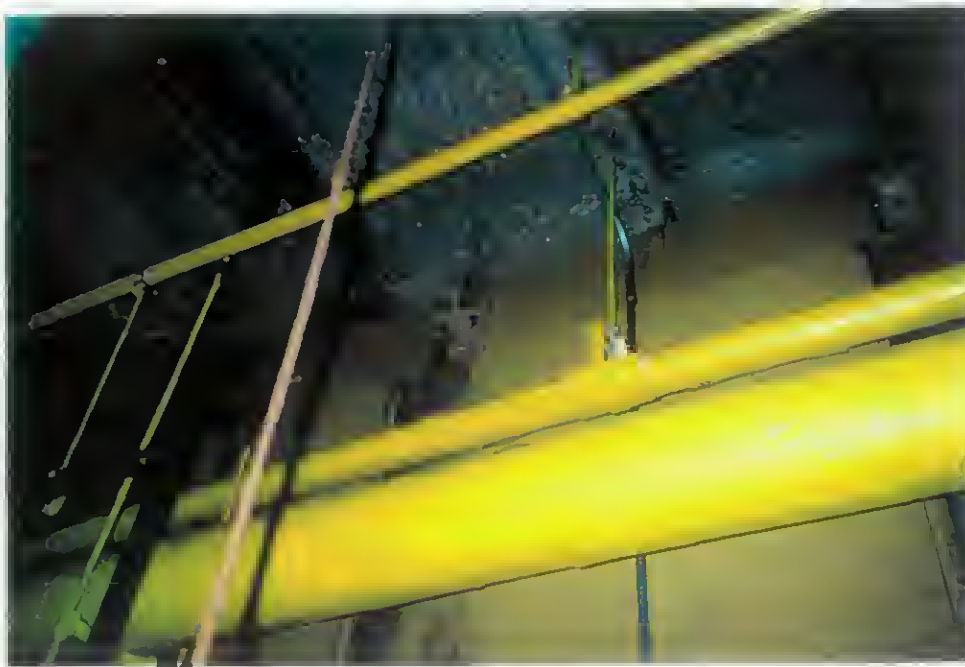
Photograph 2

**Existing
structure at 8th
floor below the
MER. Spray-
applied
fireproofing and
rigid panel sound
insulation are
visible**

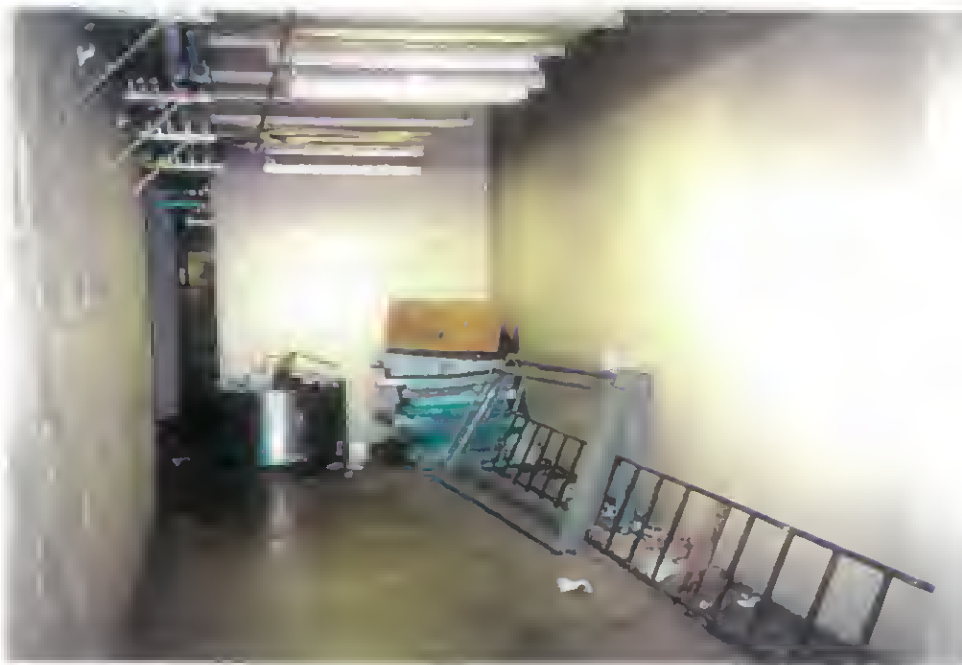
Photograph 28

Stored debris
blocking
corridor on B1
level

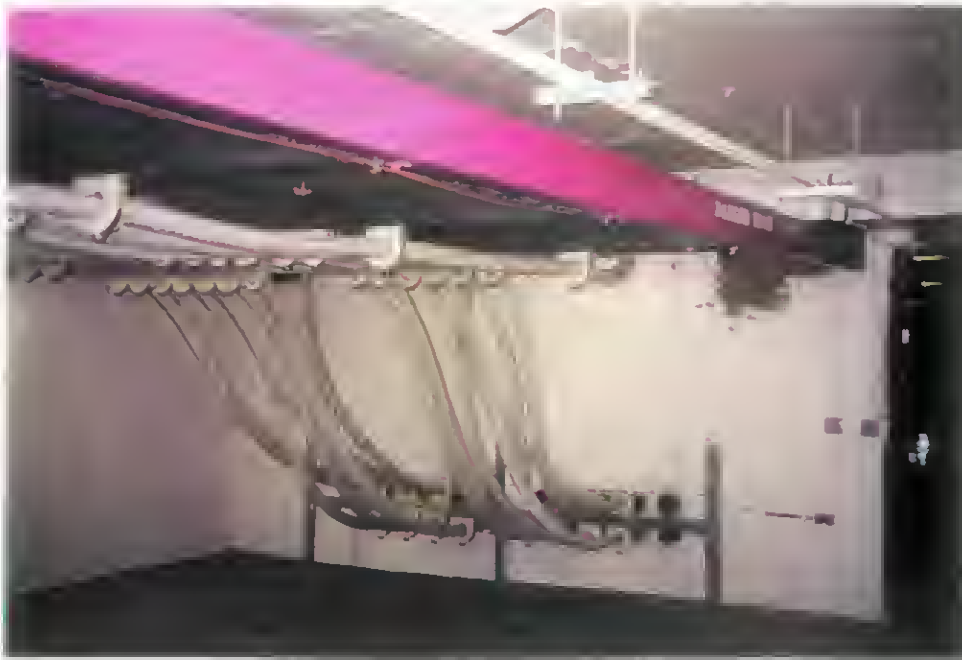
Photograph 17

Switchgear
within the
Primary
Distribution
Center

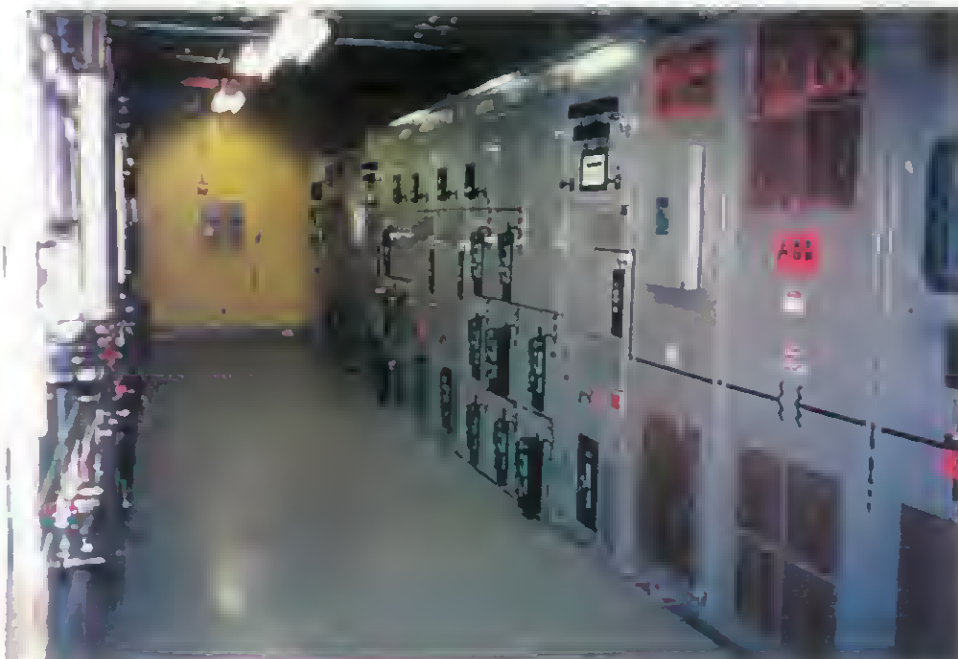
Photograph 18

Recently
upgraded high
voltage feeders

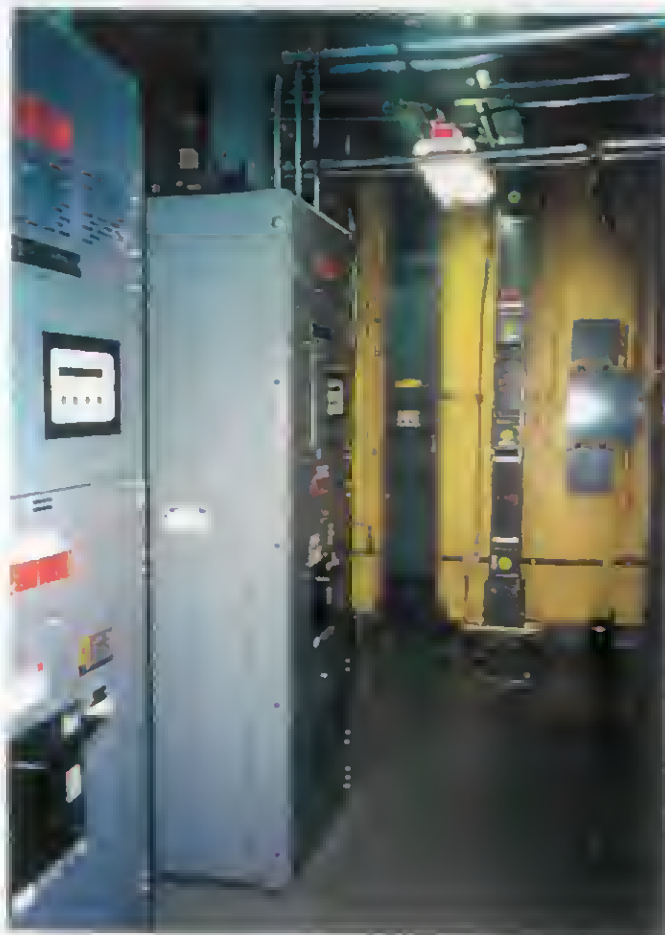
Photograph 19

Upgraded
electrical
substation

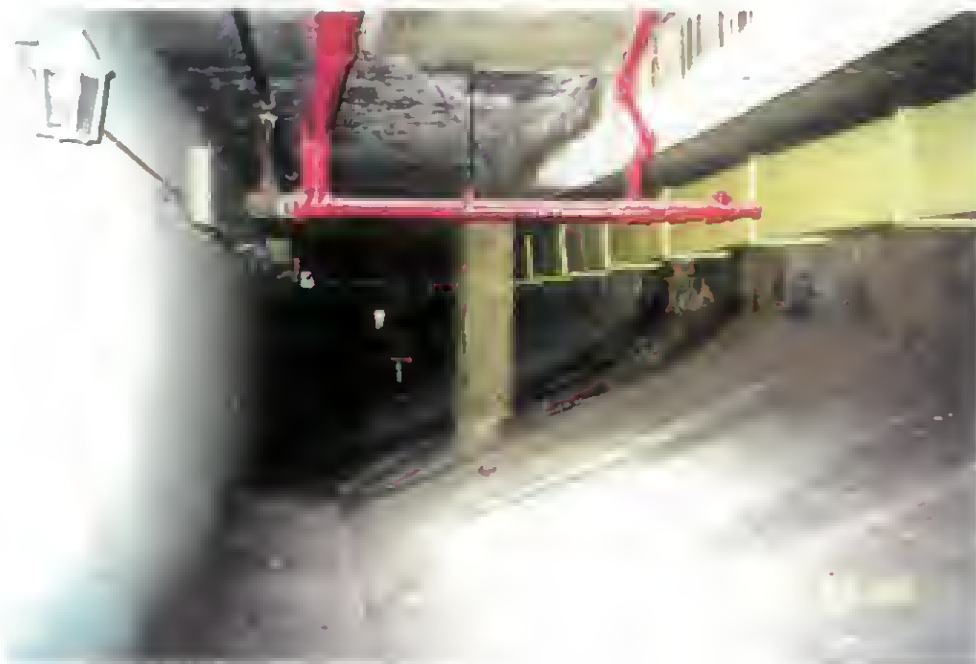
Photograph 1

Slurry wall exposed
in Level B5

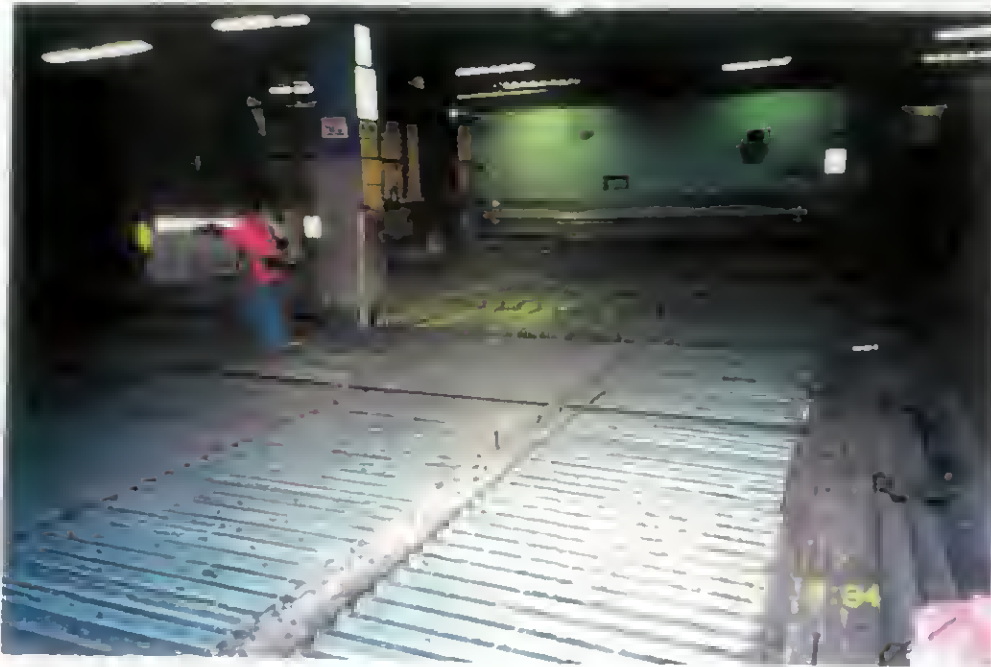
Photograph 9

New slab being
installed in loading
dock area - start of
multi-stage program

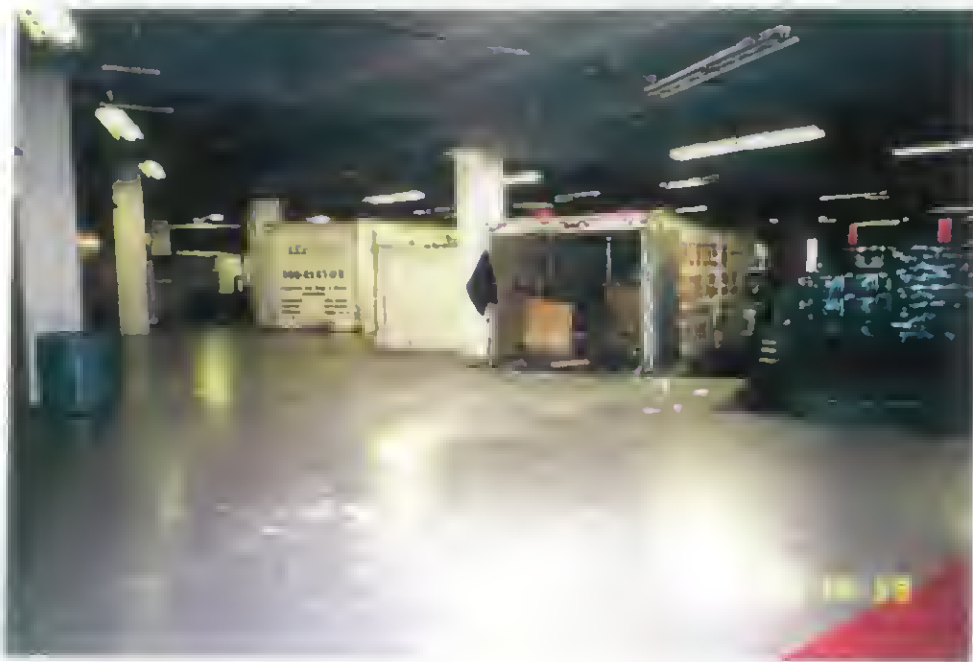
Photograph 10

Loading dock area

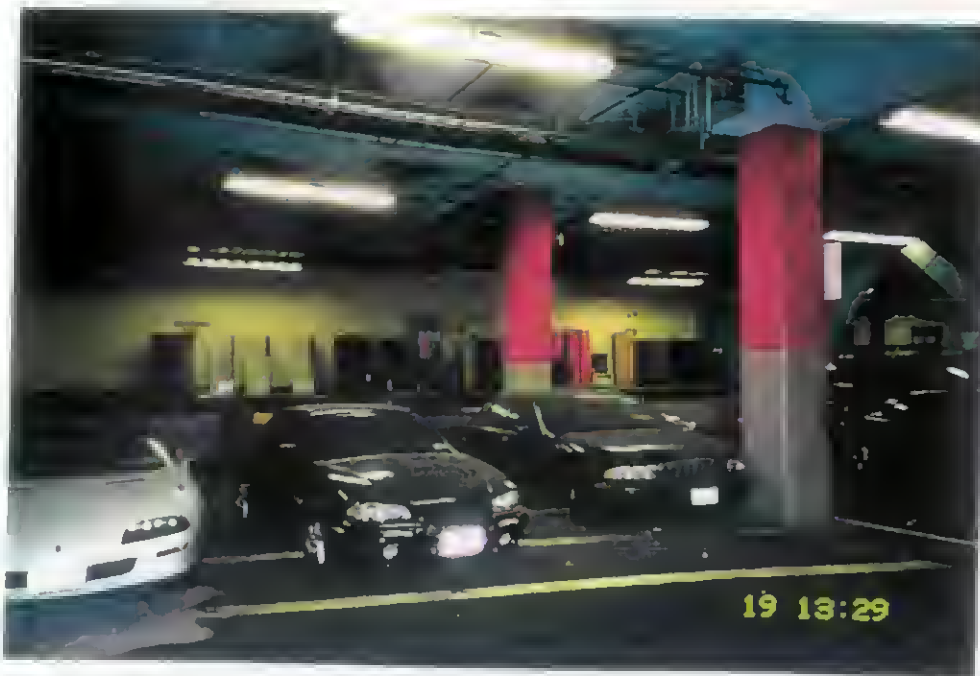
Photograph 11

**Loading dock area
for US Customs
Buildings**

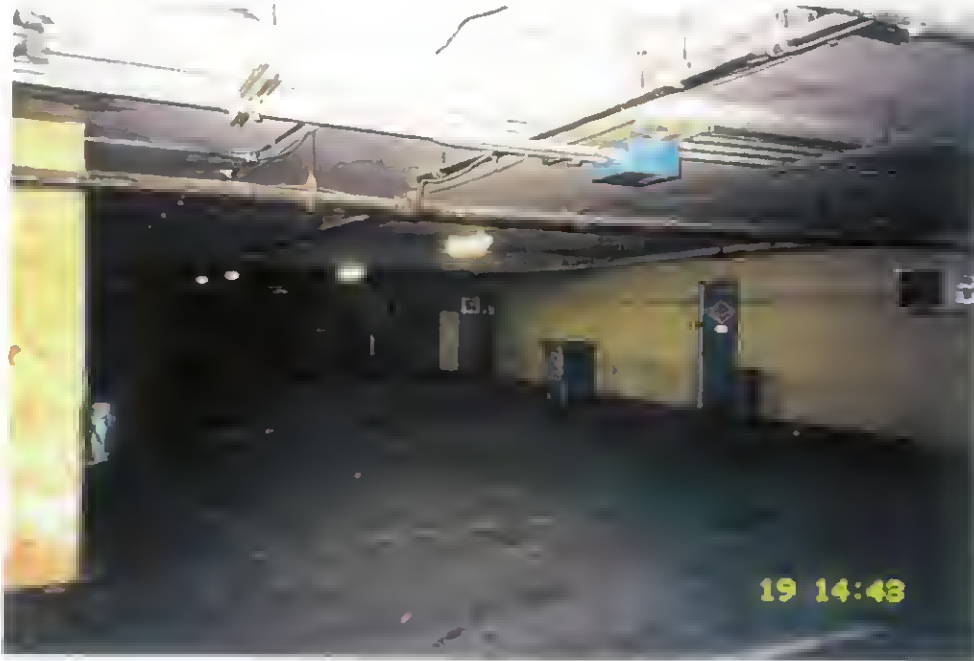
Photograph 15

Leased offices at
former parking area
(B1) for Marriott
Hotel

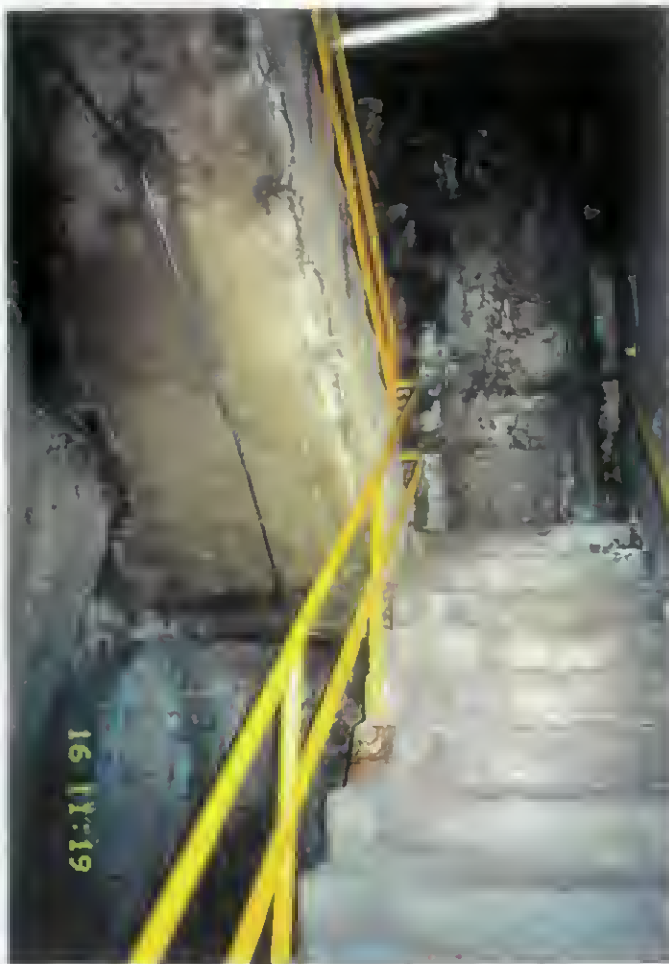
Photograph 21

Stair in projection
serves as PATH
emergency exit

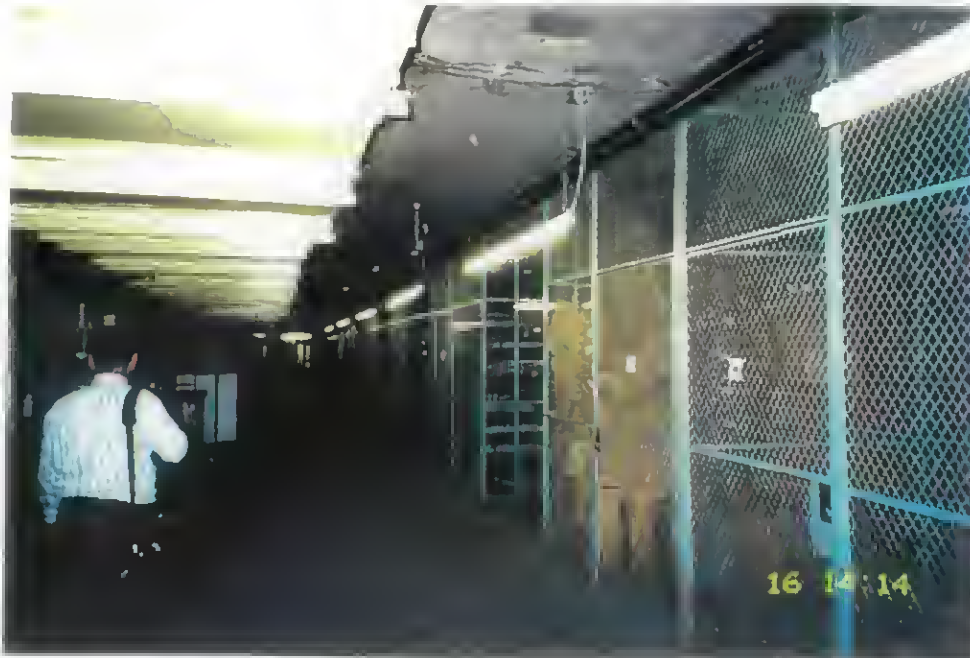
Photograph 23

B5 and B6 storage
spaces

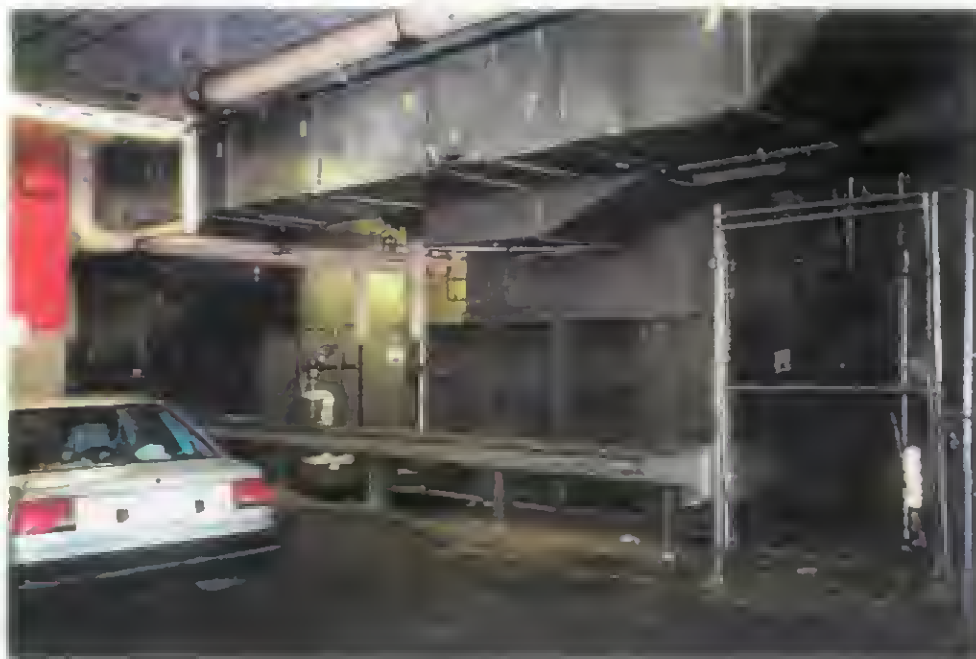
Photograph M1

Heating and
ventilating unit in the
loading dock area

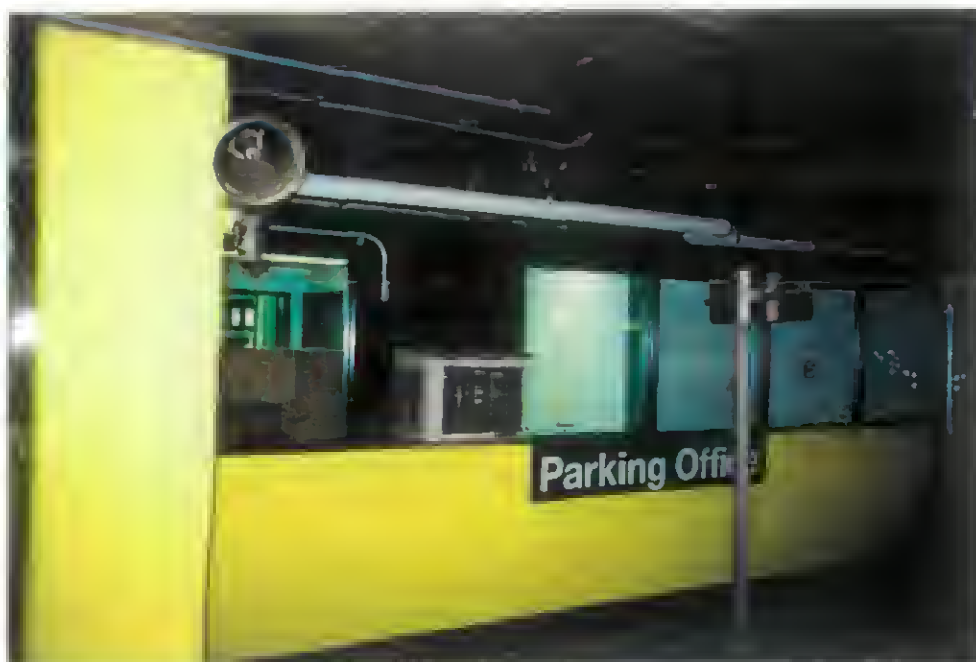
Photograph M2

Window style air
conditioning unit
used in the parking
office

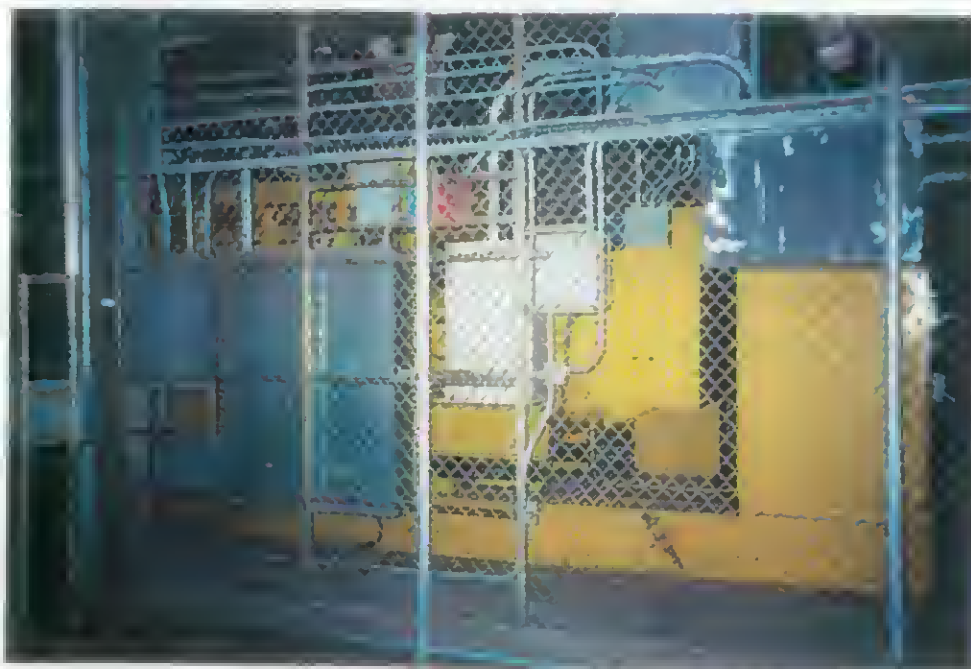
Photograph M8

**Tenant emergency
generator in the
northwest projection
area**

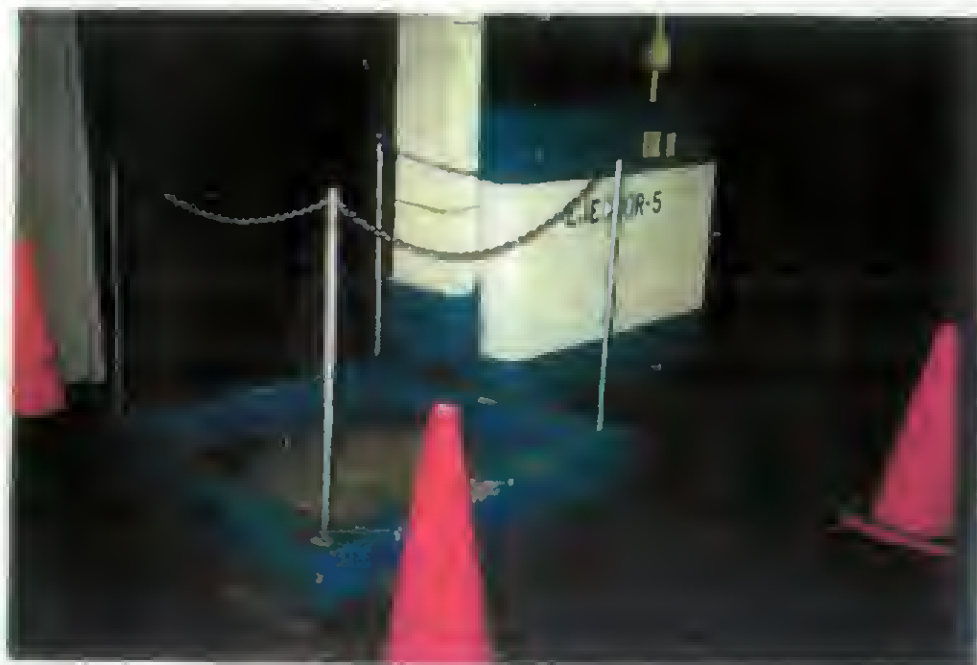
Photograph M9

Typical sewage
ejector pit
